# Manhole Inspection Summary

Manhole # S3700\_017MH

**Location** Address: **2417 BRENTWOOD AVE**

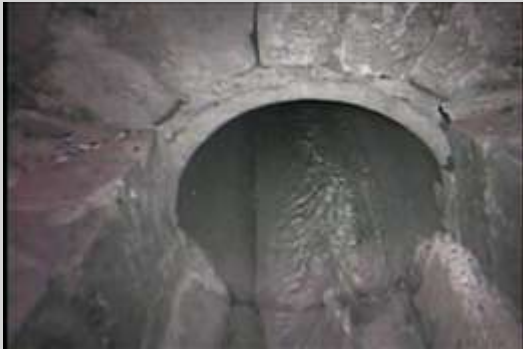
### 8 in. Circular Gravity Sewer Pipe Out @ 12 O'Clock

Rod and Bar (Angled)

Pipe Material: **Clay** ☐ Pipe Lined

Infiltration: **None** Pipe Seal Cond: **Unknown**
